# **ANP District Headquarters Facilities in Helmand and Kandahar Provinces Have Significant Construction Deficiencies Due to Lack of Oversight and Poor Contractor Performance**

**October 27, 2010**

SIGAR Audit-11-3

## ANP District Headquarters Facilities In Helmand and Kandahar Provinces Have Significant Deficiencies Due to Lack of Oversight and Poor Contractor Performance

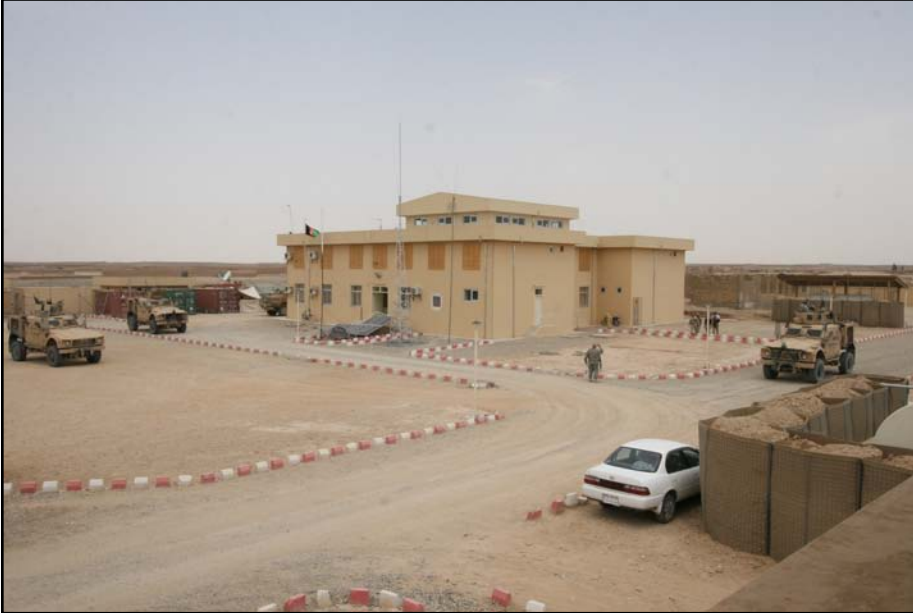
**Photo 1: Nahri Saraj ANP District Headquarters**

According to the contract documents, each completed compound should contain a central headquarters building that includes prisoner holding cells, administrative offices, billeting areas, food preparation and dining facilities, latrines with showers, and an armory. Each compound should also have a perimeter wall, four guard towers, a well house, water storage tank, and fuel storage for both diesel and propane. Photo 1 shows one completed facility at Nahri Saraj.

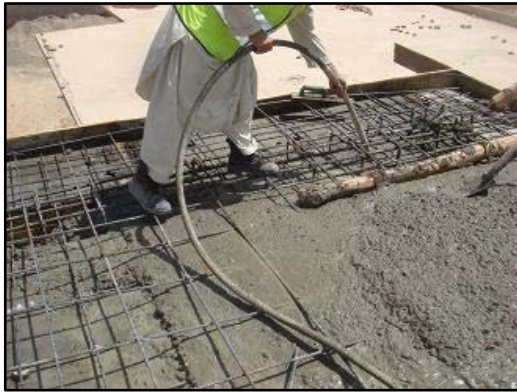
**Photo 2: Placement of Watery Concrete Mix**

not appear to meet slump test standards, indicating weak concrete. Photo 2 shows a construction worker pouring a watery concrete mixture, not likely to meet concrete test standards, for a roof slab at one of the six sites. Photo 3 shows poor concrete at what appears to be a slab-on-grade at the Garm Ser site.

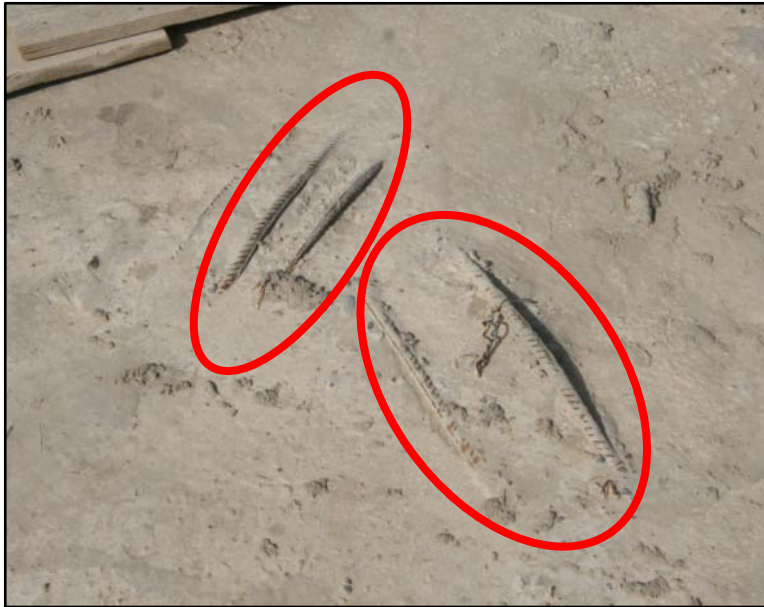
**Photo 4: Exposed Randomly Placed Steel Reinforcing in Concrete Roof Slab at Garm Ser Site**

Improper installation of steel reinforcement bars within concrete work also posed a significant risk to the structural integrity of some completed buildings. The contract documents provided details on where steel reinforcement should be placed within a concrete structure. For example, on the roof slab, the contract documents indicated that two perpendicular grids of steel reinforcing bars should be placed in the top and bottom portions of the slab and covered with a minimum amount of concrete. At several locations we observed randomly placed reinforcement bars protruding through the roof slab. Randomly placed steel bars do not provide the required structural capacity for the building and exposed steel will corrode and weaken the structure. Photo 4 shows randomly placed steel reinforcement on the concrete roof slab at the Garm Ser site, in breach of contract specifications.

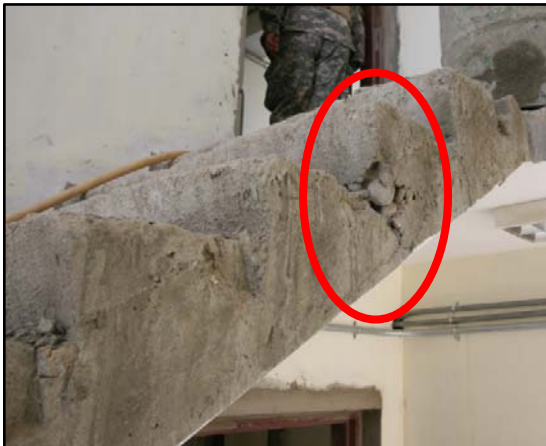
**Photo 5: Poorly Formed and Consolidated Concrete Stairs at Garm Ser Site**

Our inspections found concrete stairs at facilities that were poorly formed, improperly constructed, and comprised of poor concrete with questionable strength. The cast-in-place concrete stairs at all six sites did not conform to the construction drawings either structurally or architecturally. The plans indicated that the stairs were intended to be monolithically cast-in-place reinforced concrete with a curved metal wearing strip embedded at the edge of each step and sealed with a chemical sealant. The treads and risers of the stairs we observed were of varying dimensions. We also observed that the steps were formed separately from the sloped base of the stairs, creating a weakened section that could fail under normal use. Photographs 5 and 6 shows poorly consolidated concrete and improperly formed stairs at Garm Ser.

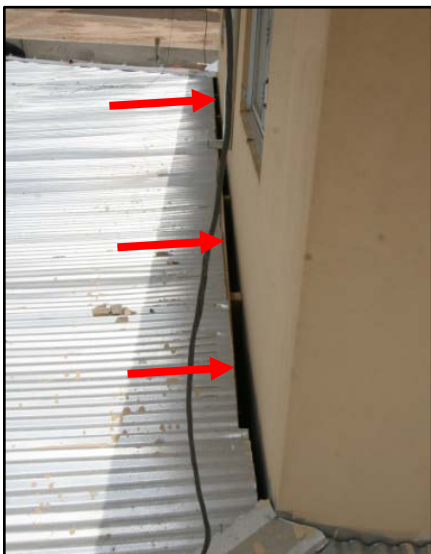
**Photo 7: Gap Between Roof Panels and Exterior Wall at Nahri Saraj Site**

Photograph 7 shows a large gap between the metal roof and the exterior wall at Nahri Saraj that will allow water to penetrate the sub-structure. Photograph 8 shows a damaged roof panel with improperly installed flashing.

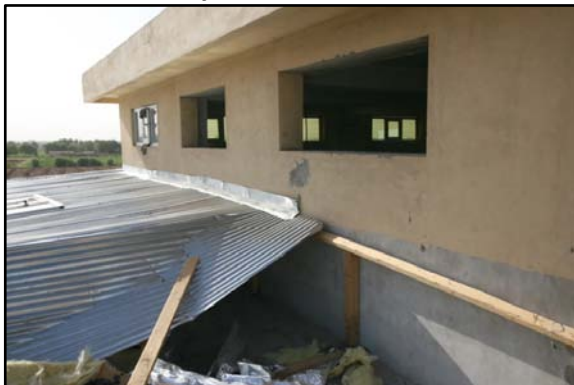
**Photo 9: Partially Demolished Roof at Nad Ali Site**

At the Nad Ali site, an ANP unit forcibly occupied the site, demolishing approximately half of the completed roof structure. The remaining portion was poorly constructed, sagging significantly when weight was applied. Photo 9 shows the partially demolished roof at Nad Ali.

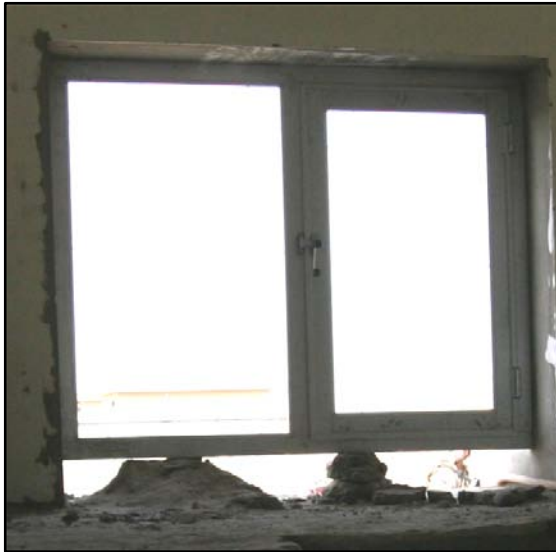
**Photo 10: Poorly Installed Window  
Supported by Rocks at Garm Ser Site**

The contract requirements indicated that the windows in the headquarters buildings should be commercial-grade, insulated windows with laminated glass and exterior insect screens. The installed windows in the headquarters buildings at all six sites were not as specified. We found inferior, residential-grade window frames that operated with difficulty and appeared to be easily damaged. Many window frames did not contain glass and, if glass was installed, it was single-pane, non-laminated glass. In addition, none of the required insect screens were installed at any of the six sites. At 4 of the 6 sites, the windows were not only lesser quality, but many were smaller than required. At 3 of the 6 sites, window installation was poor with large gaps between the rough openings in the wall and the installed window frame. One window at Garm Ser was installed with a gap so large that the window had to be supported by rocks (see photo 10).

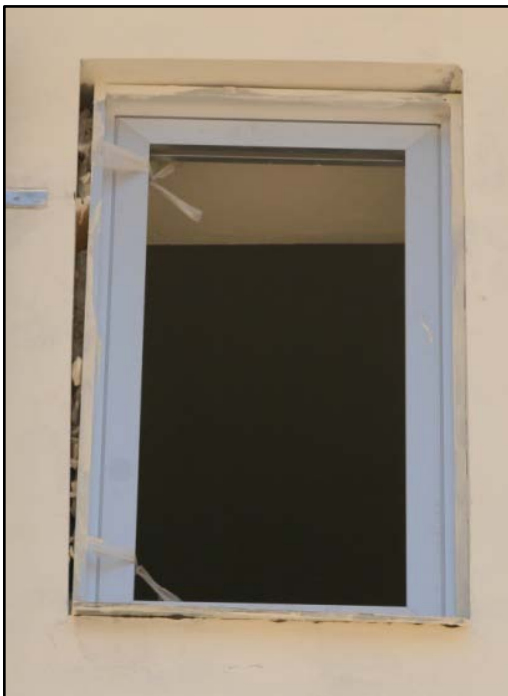
**Photo 11: Poorly Installed Window at  
Takha Pul Site**

Left in place, these inferior windows and the poor installation will create significant problems for the facilities in the future, including excessive energy use and replacement demands. AED-S estimated the cost of correcting this deficiency at more than \$120,000. Photo 11 shows a poorly fitted window typical of the installation at Takha Pul.

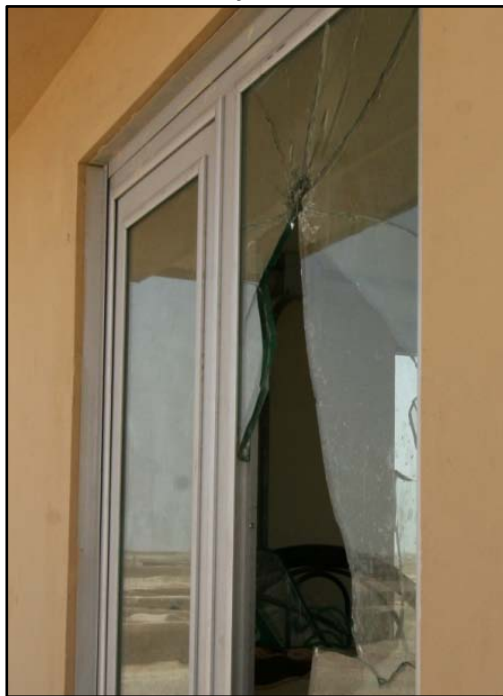
**Photo 12: Ballistic Glass Shattered by  
Bullet at Nahri Saraj Site**

The contract requirements further state that the windows in all the guard towers and guard shacks must be of ballistic quality. With the exception of one location where windows were installed, we observed inferior, residential-grade, single-pane windows in place of the required ballistic glass. At Nahri Saraj, the only site where ballistic glass was installed, one window had been shattered by the impact of a bullet (see photo 12).<sup>17</sup> At the Spin Boldak site the window opening was filled with concrete blocks, which eliminated the ability to see that avenue of approach when he is inside the guard tower.

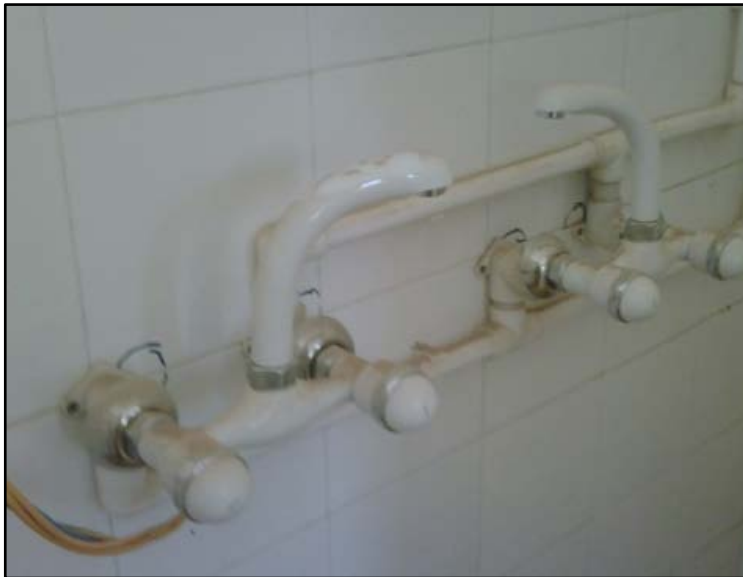
**Photo 13: Residential Grade "Goose-Neck" Faucets at Takha Pul Site**

The contract required that all faucets be chrome-plated brass with a single mixing lever. We found that at the four sites where faucets were installed, none met the specification requirements. At two of the sites, dual-handle residential-grade plastic faucets were installed. Chrome-plated faucets were installed at the other two sites, but they appeared to be residential grade and also had two handles. At all four sites, the installed faucets did not appear to be able to withstand the heavy use expected at this type of facility. Photo 13 shows the plastic, "goose-neck" faucets that do not meet contract requirements, installed at Takha Pul.

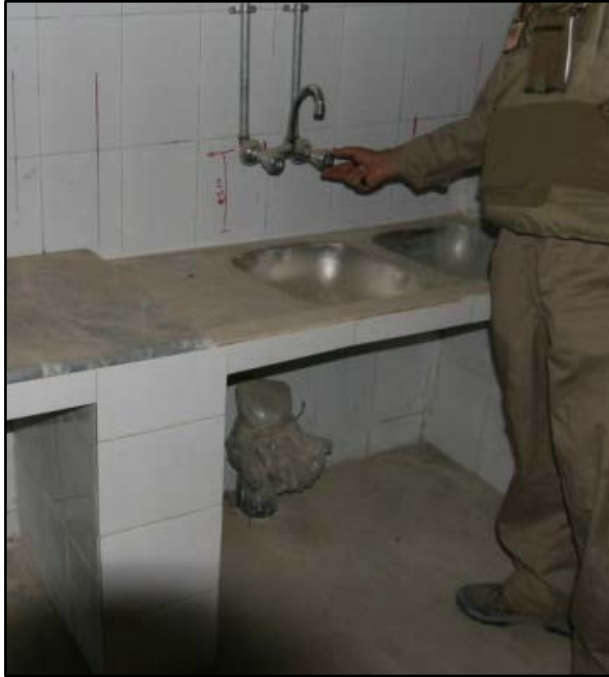
**Photo 14: Residential Grade Undersized Scullery Sink at Nad Ali Site**

At 3 of the 6 sites, the scullery sinks installed did not meet contract requirements or specifications. The contract and specifications required stainless-steel, free-standing sinks capable of accommodating a 3-foot diameter pot. None of the sinks we inspected met either of these specifications. Instead, the sinks installed were counter mounted and appeared to be approximately 6 to 9 inches deep and of residential quality. At the Nahri Saraj site, SIGAR observed ANP kitchen staff preparing food in pots approximately 2 feet in diameter. Photo 14 shows the substituted, undersized scullery sink at the Nad Ali site.

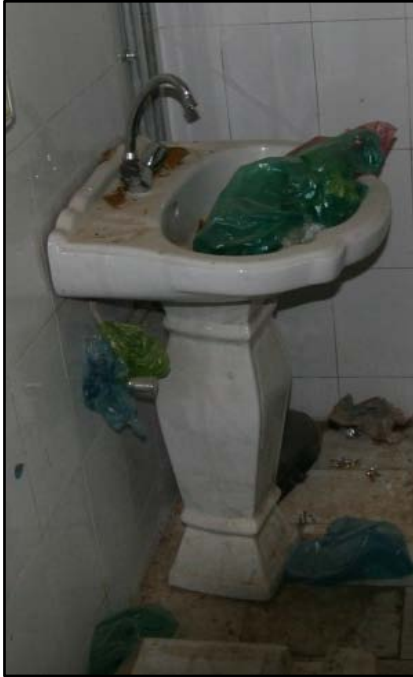
**Photo15: Unauthorized Pedestal Sink at Nad Ali Site**

The contract and construction documents specify that sinks throughout the project are to be trough-type sinks constructed of concrete blocks with a tile exterior; however, at 4 of the 6 sites, residential-grade porcelain sinks were substituted. AED estimated that it will require approximately \$30,000 to correct this deficiency. According to USACE officials, Afghan men often stand or sit on the sink to wash their feet, frequently breaking the porcelain pedestal sinks installed in ANP facilities. Photo 15 shows an unauthorized residential-grade porcelain sink and photo 16 shows a properly constructed trough-style sink at Nad Ali.

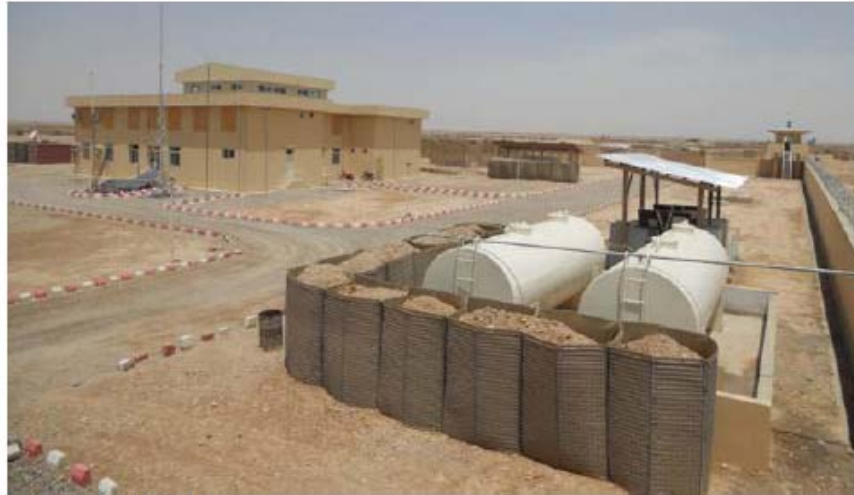
Figure 1 Nahri Saraj

- Electrical wiring runs into building through a knocked out hole in the exterior wall.
- Under sized and poorly constructed storm water outlet structures.
- Inadequate exhaust hood, approximately 1/8th of the required size, powered by an extension cord. Cooking area with propane cylinders located in the kitchen. Cook top constructed on the wrong wall.
- Per contract requirement, the contractor provided, and the USACE reviewed and approved a detailed landscape plan that included trees, grass, shrubs, and sidewalks. However, the project was accepted and turned over with no landscaping installed.

USACE Comment: All deficiencies have been corrected and the facility has been turned over for use.

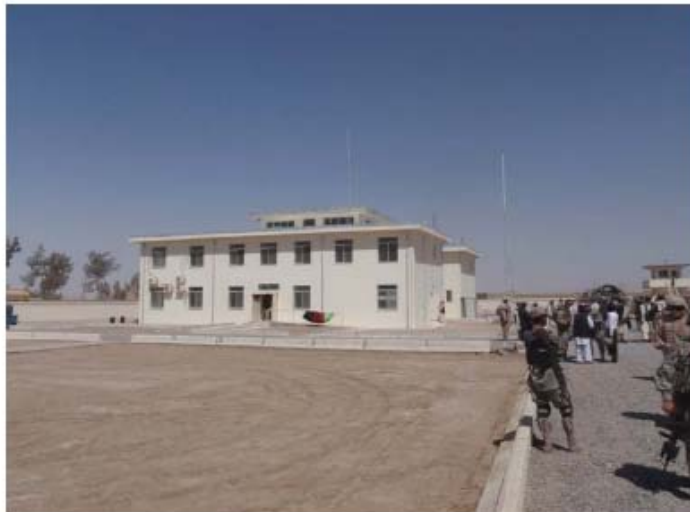
Figure 2 Spin Boldak

- Plastic plumbing pipe exposed in bathrooms.
- Gas fired heaters and gas supply piping with hand valves in prisoner cells.
- Approximately 1400 linear feet of concrete channel for storm water runoff omitted.
- Substitution of 30 portable propane cylinders for the required single 5500 liter tank.
- The project has been accepted with no landscaping installed as required by the contract.

USACE Comment: All deficiencies have been corrected and the facility has been turned over for use.
